Field Survey of the Camaná, Perú Tsunami of 23 June 2001

Emile A. Okal¹, Lori Dengler², Sebastian Araya², Jose C. Borrero³, Brandon M. Gomer¹, Shun-ichi Koshimura^{4,5}, Gustavo Laos⁶, Daniel Olcese⁶, Modesto Ortiz F.⁷, Matthew Swensson³, Vasily V. Titov⁴, and Fernando Vegas^{6*}

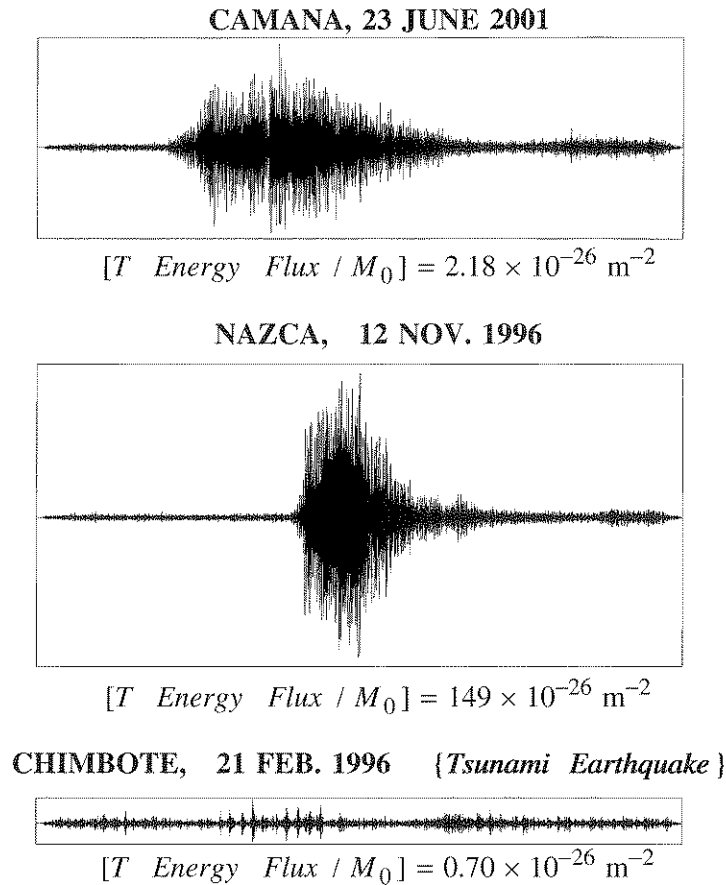
▲ **Figure 3.** Comparison of teleseismic *T*-wave records for three large Peruvian earthquakes. Top: the 2001 southern Perú earthquake; center: the 1996 Nazca earthquake; bottom: the 1996 Chimbote tsunami earthquake. All records are 1,000-second time windows from the broadband vertical (BHZ) channel at the IRIS station RAR (Rarotonga, Cook Islands) and are plotted on the same scale after applying a high-pass filter for $f > 2$ Hz. The *T*-phase energy flux to moment ratio is defined by Okal *et al.* (2002). Note its intermediate value for the 2001 wave train, the relatively long duration of the latter, and the strongly deficient *T* waves of the 1996 tsunami earthquake.

is further supported by an examination of *T* waves recorded on the IRIS broadband seismometer at Rarotonga (RAR; Figure 3). The ratio of *T*-phase energy flux to seismic moment is intermediate between those of the other two recent large Peruvian earthquakes, the tsunami earthquake at Chimbote on 21 February 1996 (*M* 7.4) and the regular Nazca event of 12 November 1996 (*M* 7.7). The 2001 Southern Perú earthquake shows a significant trend toward slowness without exhibiting the strong deficiency in high frequencies characteristic of a full-blown, truly slow “tsunami earthquake.”

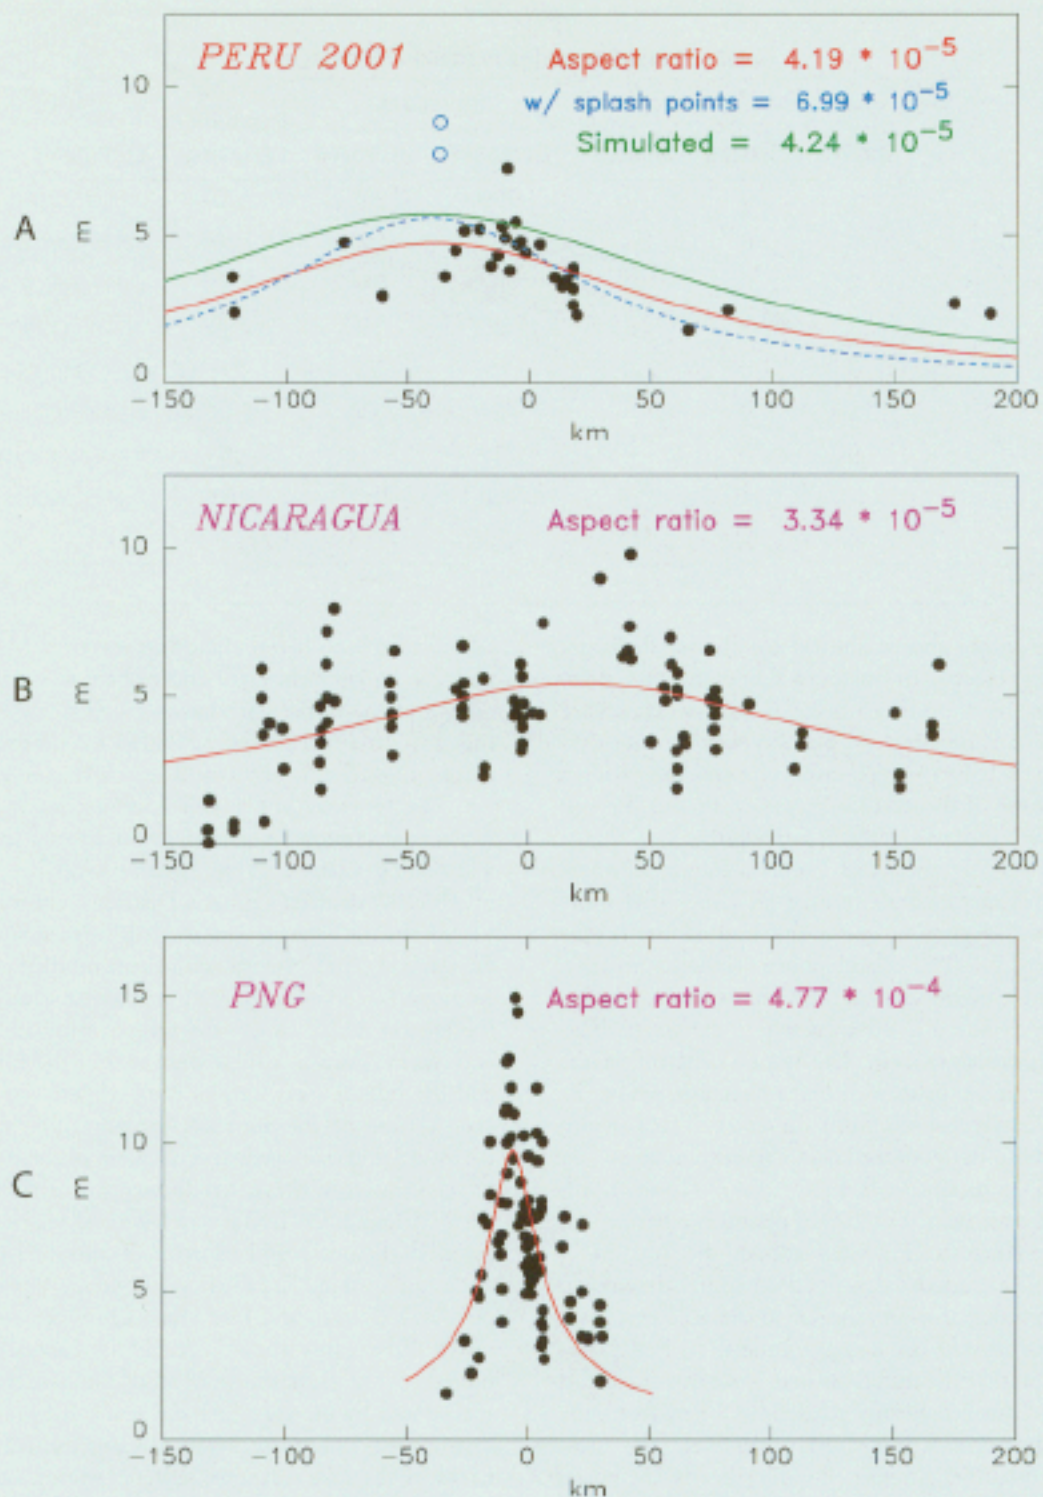
▲ **Figure 8.** Distribution of runup values as a function of distance along the beach, plotted for the 2001 Peruvian earthquake (A), the 1992 Nicaragua tsunami earthquake (B), and the 1998 Papua New Guinea (PNG) event (C). All three frames use common scales. The solid dots are the original runup values measured by the survey team for Peru, reported by Satake *et al.* (1993) for Nicaragua, and reported by Synolakis *et al.* (2002) for PNG. In each case, a function of the form (1), best fit by least-squares to the data set, is shown by the solid line and its aspect ratio b/a is printed. In the case of Peru, we delete from the data set the two large values of runup (open circles) corresponding to splashing against the cliff at Playa Chira; their inclusion would significantly bias the aspect ratio (dashed curve). The simulated curve (dash-dotted line) is predicted by a preliminary simulation using the crude model of a laterally uniform beach featuring a break of slope at 800 m. Note that the aspect ratio of the distribution of runup is similar to that of the Nicaraguan tsunami earthquake and remains one order of magnitude smaller than for the landslide-generated PNG tsunami.

Second, the runup data shown in Figure 8 are best fit by a function of the type

the coast, and c optimizes the position of the central peak. The optimal aspect ratio, $bla = 4.2 \times 10^{-5}$, is adequately predicted by the simulation experiments of Hoffman *et al.* (2002). This value falls in the range of aspect ratios observed and computed in the near field for dislocation sources such as the 1992 Nicaragua earthquake (Figure 8B). This is in contrast to the much larger aspect ratios observed for the 1998 Papua New Guinea tsunami (Figure 8C), whose successful modeling requires an underwater landslide as its source (Synolakis *et al.*, 2002). Thus, the primary characteristics of the field of water heights surveyed after the 2001 Perú tsunami—absolute amplitude and lateral extent—are compatible with the seismologically derived dislocation source and do not require generation by an underwater landslide or slump. Preliminary modeling using a dislocation source appears to explain both far- and near-field tide gauge records of the tsunami adequately (Koshimura and Titov, 2001).

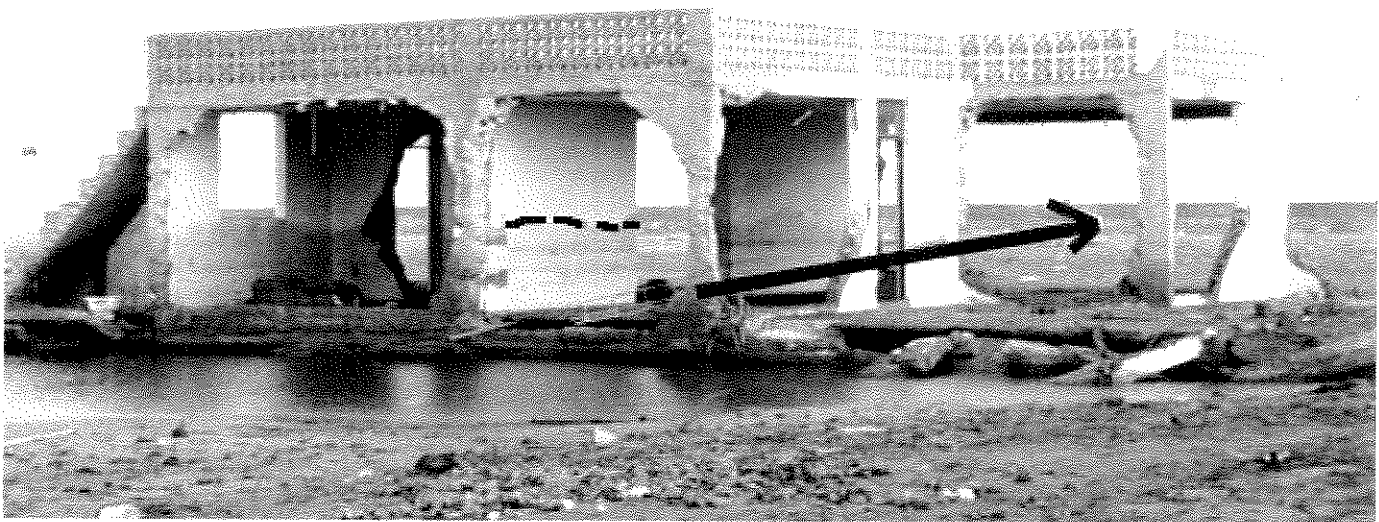
Damage to structures in the inundation zone was nearly total. Buildings in the coastal area are of three general types. In the farming areas and fishing villages, weak adobe structures and shacks of bamboo and other lightweight materials predominate. In the resort area, the majority of structures were less than ten years old and substantial. Most were built on concrete slab foundations about 25–30 cm thick with reinforced columns at the corners. Preformed brick blocks were filled in between the columns to make the walls. A number of hotels, some restaurants, and a few homes were built of reinforced concrete with thicker foundations. No wood structures were in the inundation zone. Eyewitnesses reported that the vibrations caused damage to some of the shacks and adobe structures and caused a few to collapse, but none of the stronger buildings was affected by the ground shaking.

The weak adobe structures and bamboo shacks were obliterated by the tsunami and no sign of them remained afterward. The infilled wall structures also performed poorly; walls perpendicular to the incoming wave direction were typically blown out (Figure 9). Scour was common at the corners of structures, undermining the thinner slab foundations (Figure 10). Scour also was concentrated along the edges of roads and near earthen berms separating fields. In contrast, there was no evidence of scour on the smooth undeveloped coastal platform along Playa Chira. Reinforced concrete structures with thicker foundations were most likely to survive, even when located close to the beach (Figure 7). The degree of structural damage did not correlate with distance from the coast; buildings near the limit of inundation were as likely to be destroyed as those closest to the beach. The beachfront structures were mainly restaurants, hotels, and discotheques and appeared to be more substantially constructed than the summer homes farther back from the coast.

▲ **Figure 9.** Damaged summer home, La Punta. Typical construction consists of reinforced columns on a 20–30-cm-thick concrete slab foundation with unreinforced brick-infilled walls. Walls perpendicular to the direction of the tsunami (black arrow) failed. Dashed line shows a stagnant water mark.

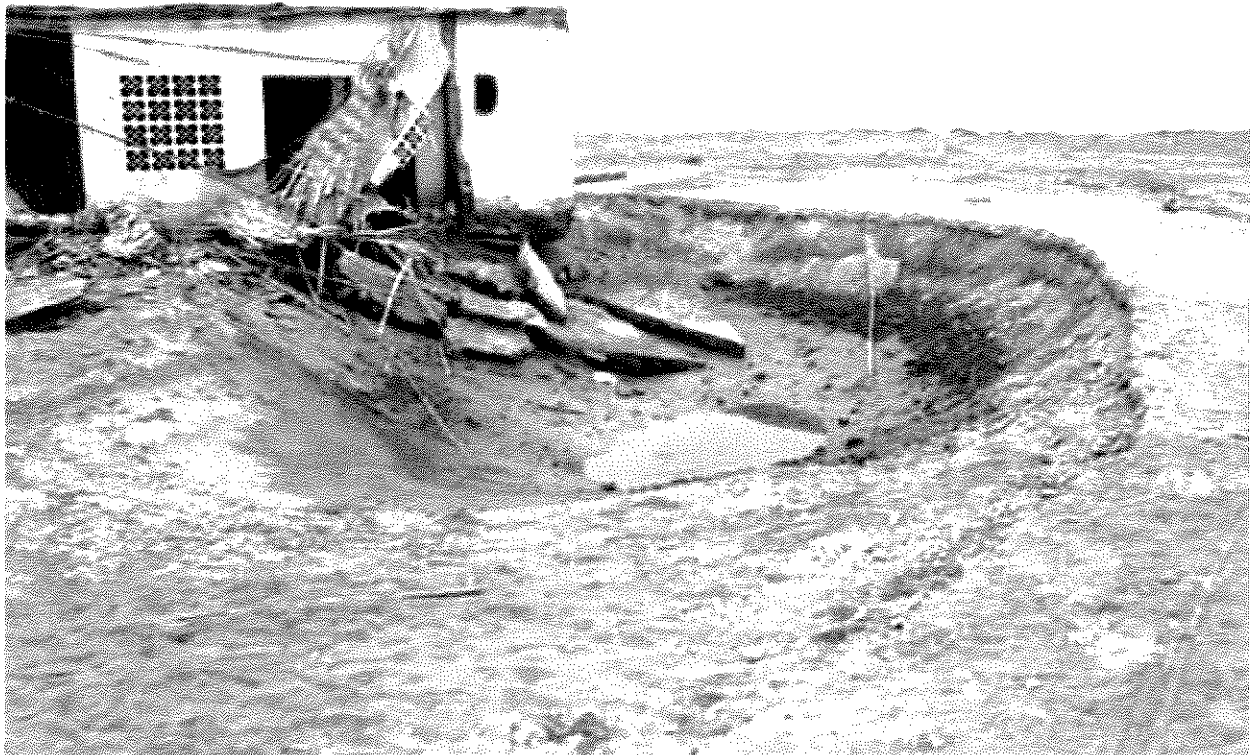
▲ **Figure 10.** Scour around the southwest corner of a La Punta house. Scour was observed at the corners of almost every structure in the inundation zone and next to paved roads.
