7

Tsunami

ITST FIELD SURVEYS

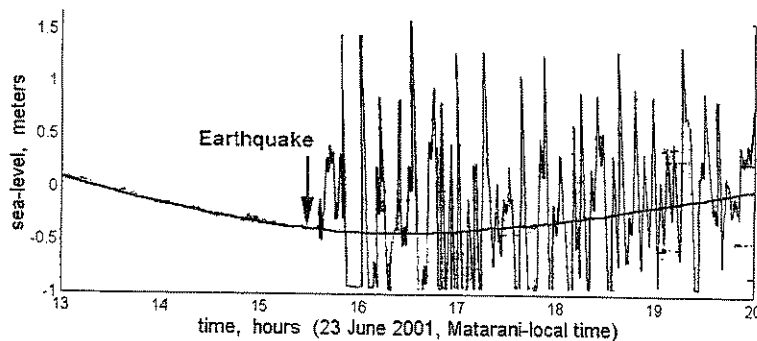
Figure 7-3. Analog recording from Matarani, Peru, 125 km from the epicenter and directly above the rupture zone. Solid line is the predicted tidal variation. The first peak (0.75 m) arrives about 11 minutes after the earthquake origin time; the second peak is the highest (1.86 m), arriving 38 minutes after the earthquake.

The closest tide gauges to the fault rupture zone were located at the Port of Matarani, 125 km away from the epicenter and directly above the rupture zone. The United States Coast and Geodetic Survey analog flotation-type paper recorder marks the first visible motion at 15:34 local time (20:34 UTC) (Figure 7-3). The motion was likely produced by oscillations of the counterweight of the gauge due to surface seismic waves. The onset of the first tsunami arrival is about 6 minutes after the origin time of the earthquake; the first peak (0.75 m) at 11 minutes. The second peak (1.86 m), at 38 minutes after the earthquake, is the largest amplitude at Matarani.

The eyewitness accounts of an initial water retreat contradict the tide gauge data. The Peruvian and northern Chile tide gauges (Figures 7-2 and 7-3; Table 7-2) all show an initial positive wave, not a drawdown. Only one observer, a woman working in a souvenir shop 20 meters from the Matarani tide gauge house, noticed an initial rise. She observed the boats in the harbor rise about one meter, and then watched the water drain so that the boats rested on the sea floor. A videographer for a Matarani television station caught this sequence on video taken from the port overlook about 5 to 10 minutes after the earthquake (Figure 7-8). The film showed what was probably the initial rise and the first drawdown. Port authorities then ordered a complete evacuation of the harbor area, and the videographer was unable to film the larger waves.

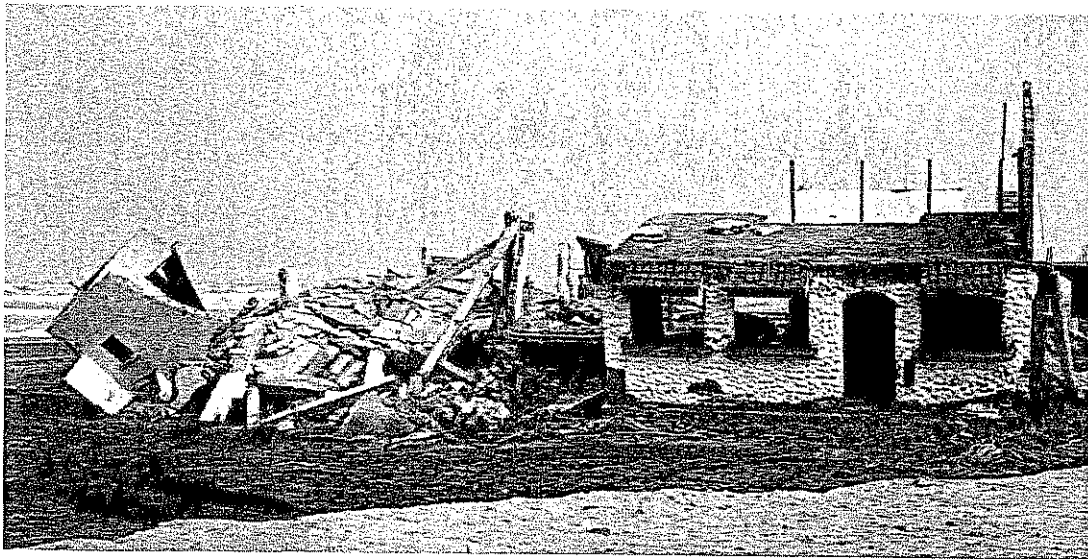
Figure 7-16. El Chorro discotheque built on filled river channel. Tsunami flow has undermined foundations of structure on the left.

The weak adobe structures and bamboo shacks were obliterated by the tsunami and no sign of them remained afterwards. Infilled wall structures also performed poorly; walls perpendicular to the incoming wave direction were typically blown out (Figure 7-13). Scour was common at the corners of structures, undermining thinner slab foundations (Figure 7-14). Scour also was concentrated along the edges of roads (Figure 7-15) and near earthen berms separating fields. In contrast, there was little evidence of scour on the smooth, undeveloped coastal platform along Playa Chira (Figure 7-5). Reinforced concrete structures with thicker foundations were most likely to survive, even when located close to the beach (Figure 7-6). However, some substantial structures built on filled river deposits failed when the tsunami completely undermined their foundations (Figure 7-16).

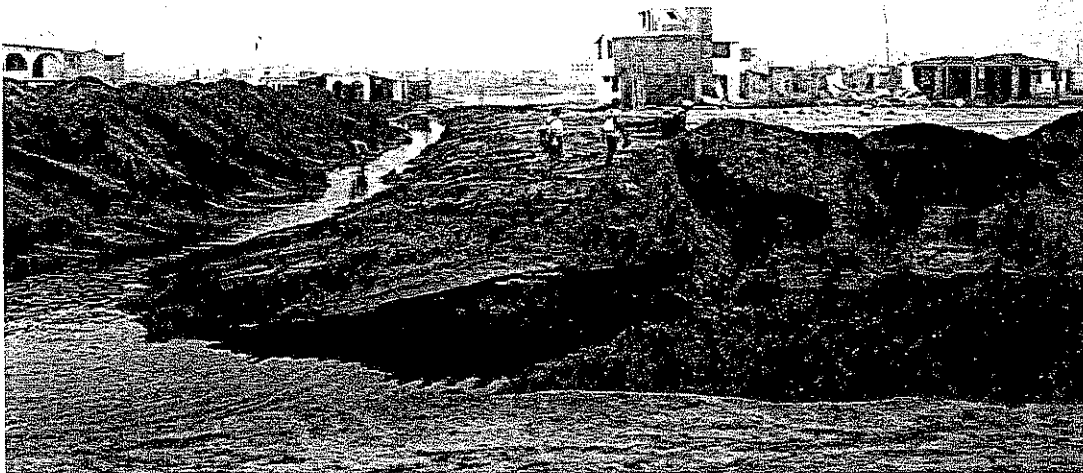
Figure 7-20. Bulldozed tsunami sand deposits, La Punta.
