Rodrigues, Mauritius, and Réunion Islands Field Survey after the December 2004 Indian Ocean Tsunami

The effects of the December 2004 Indian Ocean tsunami on the islands of Rodrigues, Mauritius, and Réunion were surveyed in March 2005. Runup and inundation were obtained at 35 sites. Measured runup ranges from 2.9 m on the southeastern coast of Rodrigues to negligible values further west on the same island, with most variations expressing the effect of differences in the structure of the coral reef. Most of the damage on Réunion was concentrated in harbors. At the main harbor of Le Port on Réunion, a 196-m vessel broke loose from its moorings and began drifting, inflicting damage on port infrastructure; this incident took place significantly later than the passage of the maximum-amplitude waves. There is a potential hazard to the Mascarene Islands from any future large earthquake in southern Sumatra. [DOI: 10.1193/1.2209190]

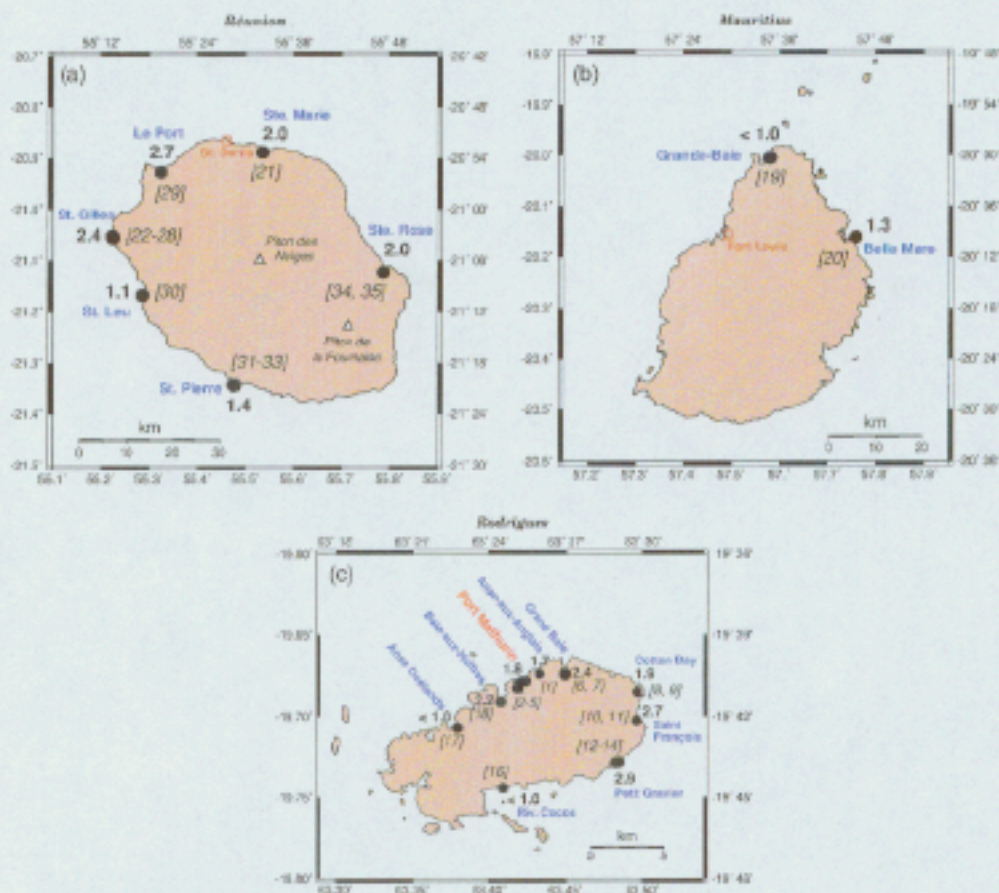
Figure 2. (a) Réunion Island, showing the data set gathered during the survey. The solid dots identify all entries that appear in Table 1, and the bold numerals indicate the largest value of runup or flow depth (in meters) recovered at each locality. Bracketed numbers in italics correspond to the site numbers in Table 1. The triangles identify the shield volcanoes composing the island, and the square identifies the capital city of Saint Denis. (b) Mauritius: the meanings of the symbols are the same as in (a). (c) Rodrigues Island: the meanings of the symbols are the same as in (a). The splash data point at Site 15 has been eliminated.

The maximum heights compiled in Table 1 and plotted in Figure 2 are typically 0.5–2.9 m, with a single value of 3.8 m at Petit Gravier, Rodrigues (Site 15), measured on a steep hill behind a narrow beach; we interpret this value as involving a splash of the wave on that relief. As documented in previous surveys, notably after the 2001 Peru tsunami (Okal et al. 2002), such data points are not representative of the general penetration of the wave.

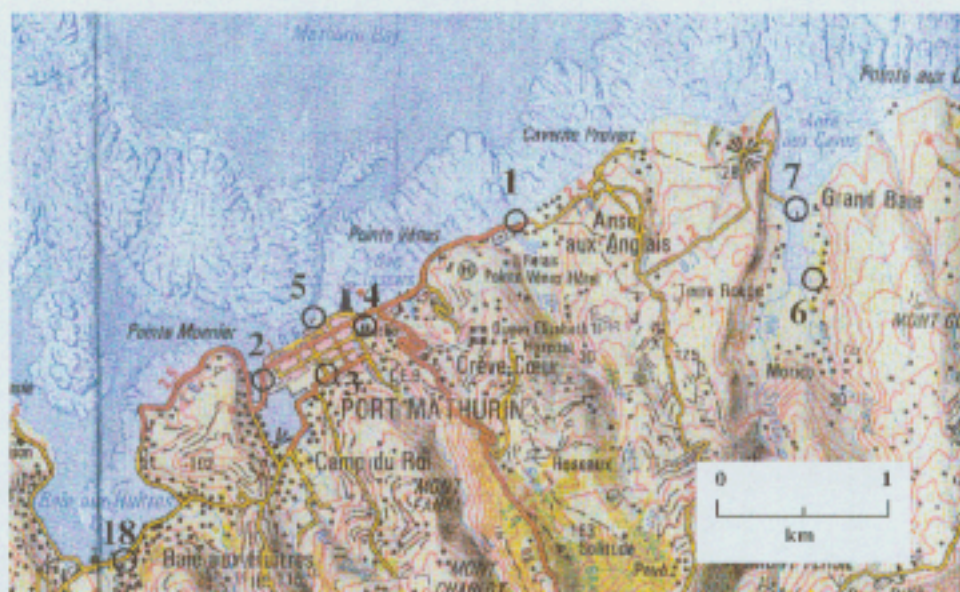
Figure 3. Topographic map of the Port Mathurin area, Rodrigues (adapted from Institut Géographique National, Paris 1982). Surveyed sites are identified by open circles and are keyed to the numbers in Table 1. Note that the road network has evolved (notably around Sites 2, 4, and 18) in the 23 years since the map was compiled.

Extensive flooding covered essentially the entire downtown area, identified in Figure 3 by its regular, rectangular street blocks, but the flow depth remained miraculously manageable, as evidenced by the individuals in Figure 5, who are seen wading through the streets. This certainly contributed to the absence of casualties. Dynamic effects of the tsunami are presented in Figures 4, 6, and 7. Figure 4 illustrates complex wave activity at Site 4 during what is probably an ebbing phase after the third wave (as discussed be-

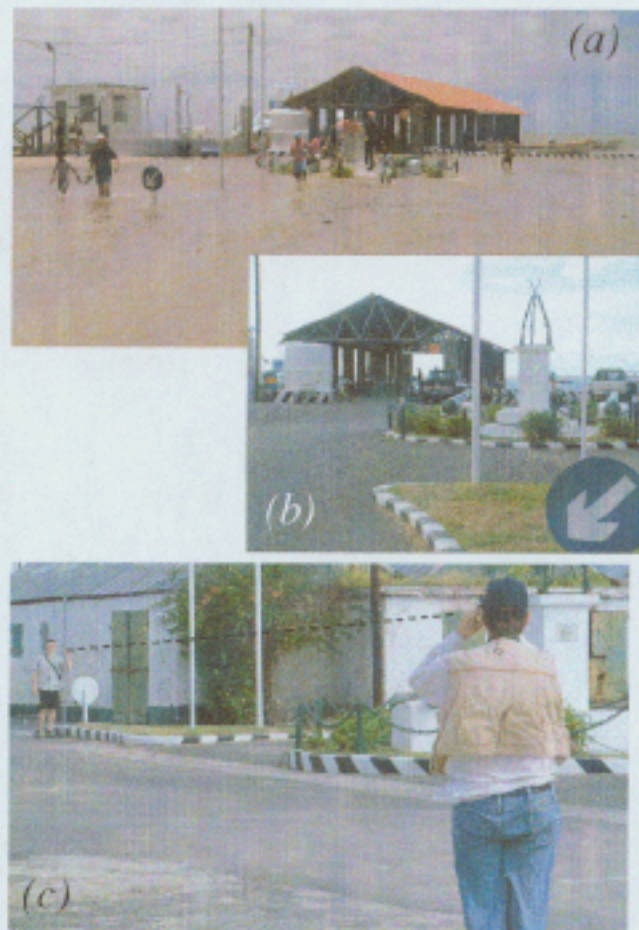
Figure 5. Site 5, traffic island and veterans memorial at the passenger ship terminal in Port Mathurin, Rodrigues. (a) Tsunami inundation, photographed at 11:50 (UTC+4) on 26 December 2004 (courtesy Rodnet Cybercafé). According to eyewitnesses, the flow depth was approximately 10 cm higher at its maximum. (b) The same location, photographed and surveyed on 5 March 2005. (c) The surveying technique for this location.

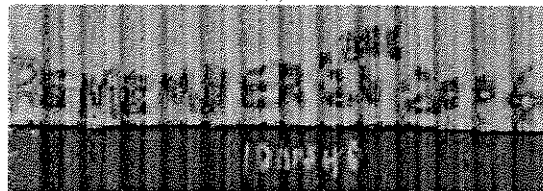
Figure 7. Site 1, Anse-aux-Anglais, Rodrigues, looking inland (south) from the seashore. (a) This shipping container, which houses a convenience store on the beach berm next to the river estuary, was displaced westward by the tsunami. The road bridge behind the container was barely overflowed by the wave, corresponding to a flow depth of 1.72 m. (b) An inscription on the container (detailed and digitally sharpened) gives the date and time of the tsunami. (c) 15-cm displacement of the shipping container.

At Site 1 (Anse-aux-Anglais, 1.2 km northeast of Port Mathurin, in Figure 3), a shipping container that housed a beach convenience store was moved 15 cm by the tsunami (Figure 7). Note the inscription of the date and time “10 hrs 40” of the tsunami on its side (the inscription, incidentally, was gone by the next day, the container being repainted as the photo was taken on 5 March 2005). As confirmed by eyewitnesses, this time corresponds to the arrival of the initial wave, which agrees perfectly with the travel time simulations of Titov (2005). It is not clear, however, at which point in the sequence the container was moved.

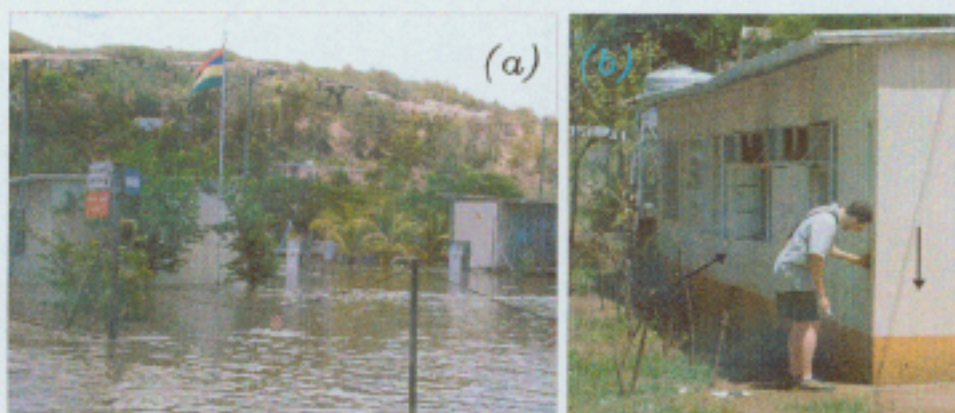
Figure 8. Site 2, service station in Port Mathurin, Rodrigues. (a) Looking west during the inundation on 26 December 2004; the seashore is at right (photo: Rodnet Cybercafé). (b) watermark, shown by arrows, was identified and surveyed on 5 March 2005 on the walls of the service station office; this office appears at left behind the flagpole in (a). Note that the water level in (a) does not correspond to the maximum flow depth, suggesting that this untimed photo was taken during an ebbing cycle of the wave.

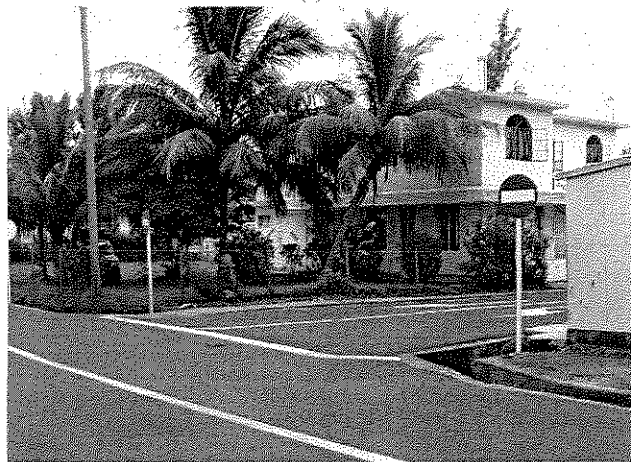
Figure 9. Site 3, mosque in Port Mathurin, Rodrigues; its location appears in Figure 3. (a) During the tsunami inundation on 26 December 2004 (photo: Rodnet Cybercafé). (b) The same location on 5 March 2005. The one-way street is oriented east-northeast; the other street leads north-northwest (at left in the photo) to the shoreline. The runup at the site is 1.99 m, for a total inundation of 334 m. The culvert visible next to the “no-entry” signpost actually connects to an outflow channel running west-southwest toward the estuary at Camp du Roi, qualifying this site as a riverbed (which is marked by a superscript in Table 1).

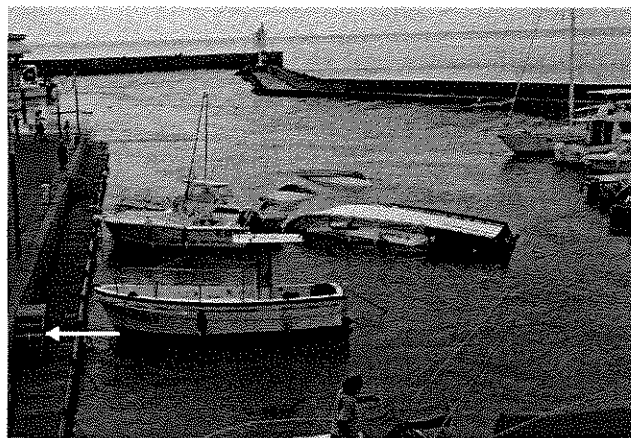
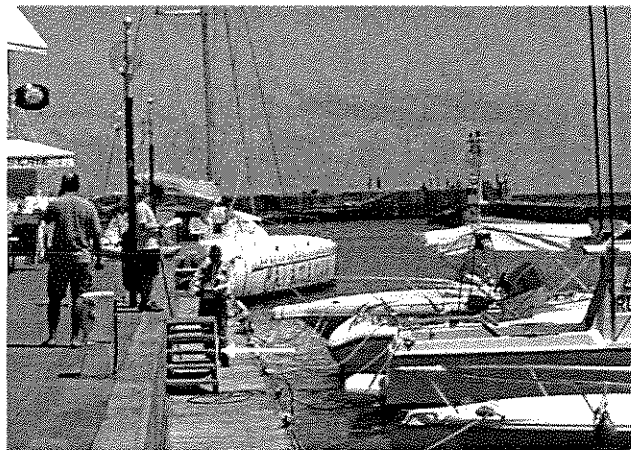
Figure 10. Site 27, Port of Saint Gilles, Réunion. (a) An area of the port at 15:14 (UTC+4) on 26 December 2004, during the ebbing phase of tsunami (photo: J.-M. Lafond). Note the three capsized boats. The arrow indicates the maximum flow depth, as described by an eyewitness. (b) The team surveying the site on 9 March 2005.

Figure 10 shows boats capsized by the tsunami, photographed in the afternoon of 26 December 2004, approximately 3.5 hours after the arrival of the first wave. This picture is representative of the action of the waves in most ports of the island. Most of the damage took place in the northern port of Sainte Marie (Site 21), where we measured runup of 2.0 m. One fishing boat and 10 leisure vessels were sunk, and an additional 44 vessels suffered some level of damage. Three mooring pontoons were damaged beyond repair, with a total loss to port infrastructure alone (not counting vessels) estimated at a preliminary figure of 400 k€ (US \$500,000). Similarly, in the port of Saint Gilles, seven boats were sunk and one 10-m pontoon was destroyed, at an additional cost to infrastructures of 120 k€ (US \$150,000).
