## THE EARTHQUAKE AND TSUNAMI OF NOVEMBER 21, 2004 AT LES SAINTES, GUADELOUPE, LESSER ANTILLES

### ABSTRACT

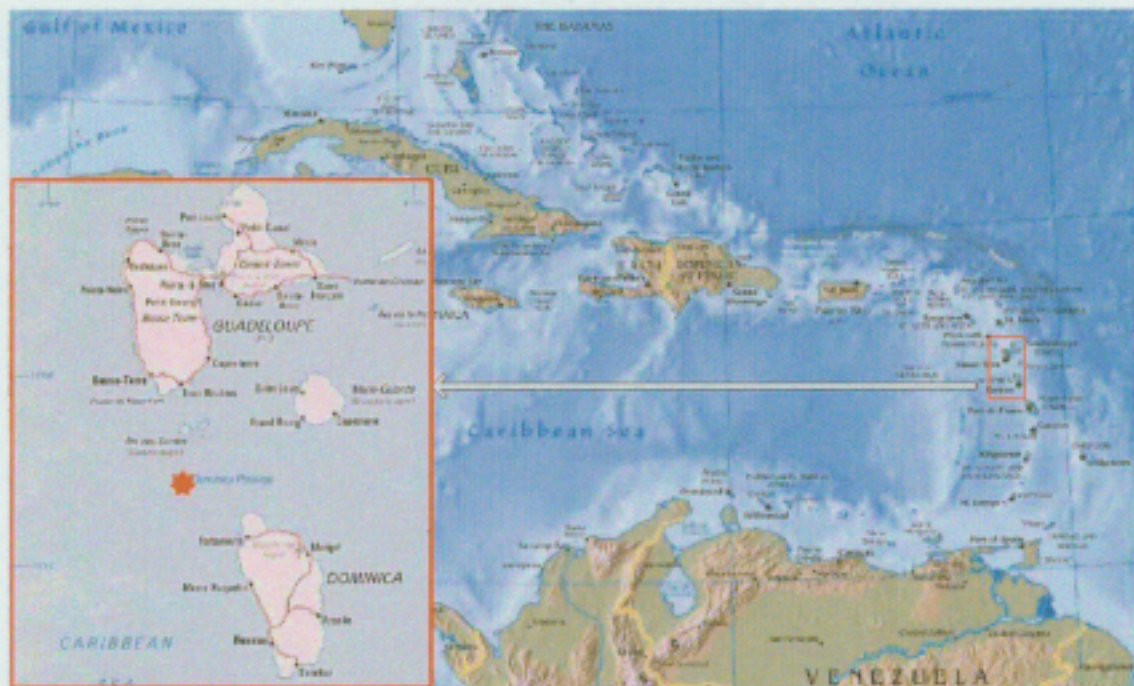
Figure 1. Map of the Caribbean basin showing the location of the earthquake of November 21, 2004.

The earthquake which occurred on November 21, 2004 at 11:41:07 UTC (07:41 local time) in the Dominica Passage, Lesser Antilles (Figure 1) was the strongest in this area since 1969. Preliminary epicentral coordinates given by the National Earthquake Information Center of the U.S. Geological Survey are 15.677°N, 61.650°W, with a focal depth of 14 km, and conventional magnitudes  $m_b = 6.3$ ,  $M_s = 6.1$ . The USGS Moment Tensor Solution has a moment of  $3.2 \times 10^{18}$  Nm ( $M_w = 6.3$ ), and a centroid location at 15.681°N, 61.693°W, 6 km depth; its focal geometry is: strike  $\phi = 327^\circ$ , dip  $\delta = 35^\circ$ , slip  $\lambda = -92^\circ$ . The Harvard CMT inversion yields a comparable geometry ( $\phi = 317^\circ$ ;  $\delta = 44^\circ$  deg,  $\lambda = -88^\circ$ ) with a moment of  $3.35 \times 10^{18}$  Nm and a centroid at 15.81°N, 61.63°W with a depth of 12 km. Thus the earthquake is readily interpreted as a shallow normal faulting event taking place in the back-arc; the slight deficiency of  $M_s$  relative to  $m_b$  could be indicative of a somewhat fast strain release, suggestive of a higher-than-normal stress drop. This is further supported by the analysis of estimated energy (Newman and Okal, 1998), which yields a slowness parameter  $\Theta = -4.59$ , slightly greater than predicted by scaling laws (-4.90). As of the time of writing, the earthquake had 8 aftershocks with  $m_b \geq 5$ , the latest and largest aftershock to date ( $m_b = 5.7$  on February 14, 2005) having inflicted additional damage in the epicentral area.

A five-year old girl was killed and two other persons injured in Trois-Rivières (Guadeloupe, approximately 35 km from the epicenter; see Figure 1 for locations). One person was injured in Capesterre (Guadeloupe) and ten people suffered minor injuries in Petites-Anses (Island of Terre-de-Bas, Les Saintes, 20 km from the epicenter). Many buildings were destroyed or damaged in locations as far away as Pointe-à-Pitre, 65 km away from the epicenter, as well as in Portsmouth, Dominica (25 km from the epicenter; see Figures 2-4). To the North, the earthquake was felt in Antigua and Barbuda (150 km) and St Kitts and Nevis (190 km) and to the South as far away as Saint Lucia (220 km). This event was widely discussed and commented in the local newspaper "France-Antilles" (Guadeloupe) and on local television. However, any information about the possible generation of a tsunami by the earthquake was notably absent from media reports, which motivated the field surveys carried out in the aftermath of the event. We give below a sample of photographs and witness reports.

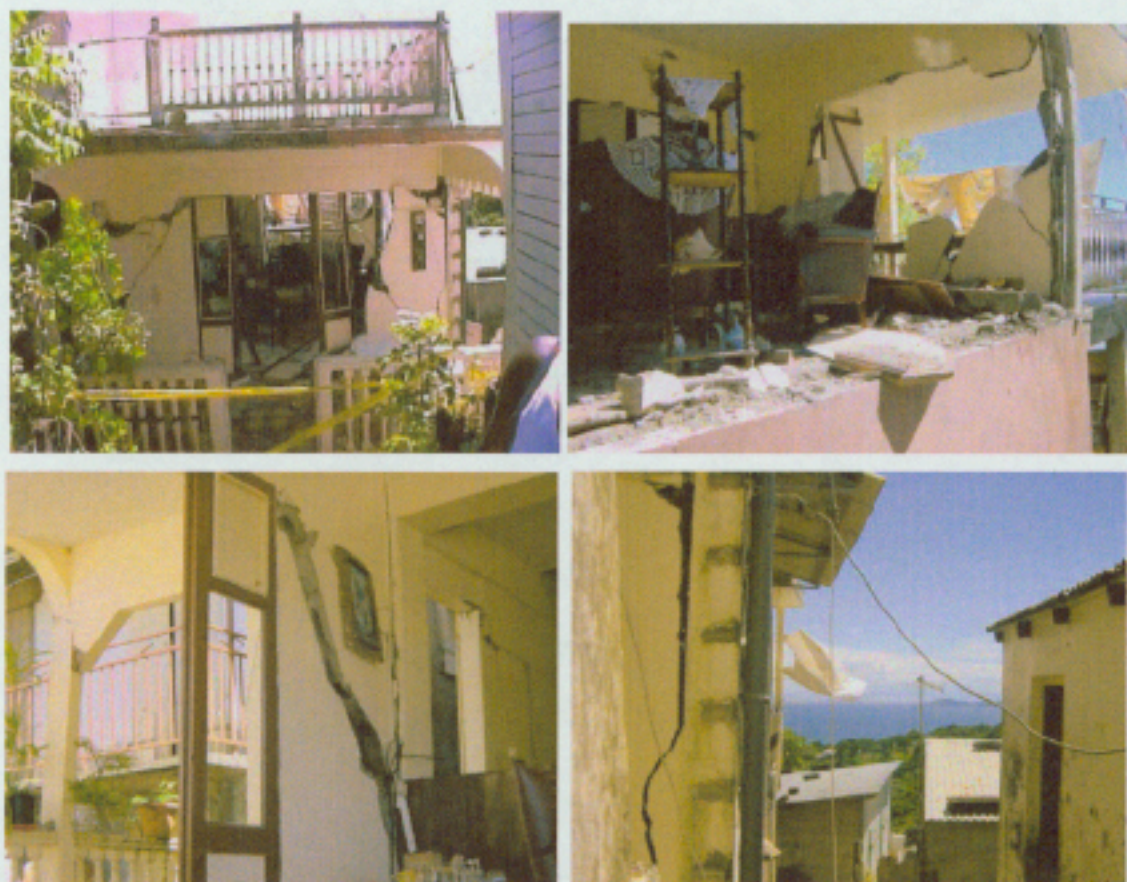
**Figure 2.** Houses at Trois-Rivières, Guadeloupe damaged during the earthquake (Photographs by N. Zahibo and A. Yalçiner). In the last photograph, the islands of Les Saintes, where the earthquake was destructive, can be seen in the background.

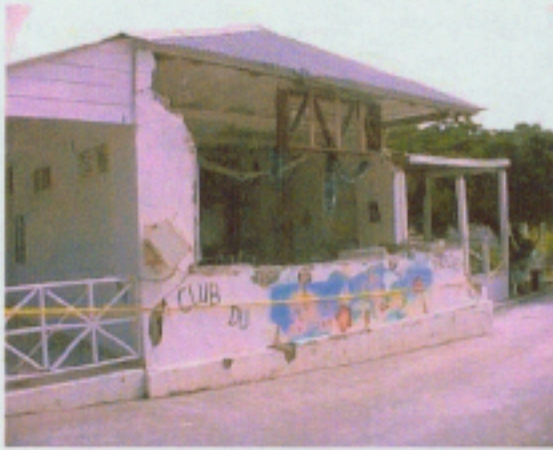
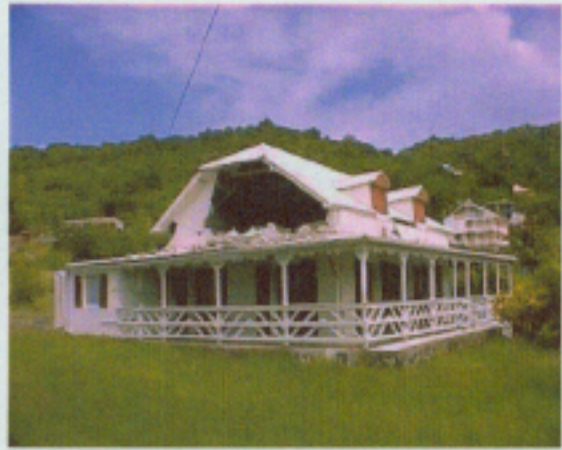
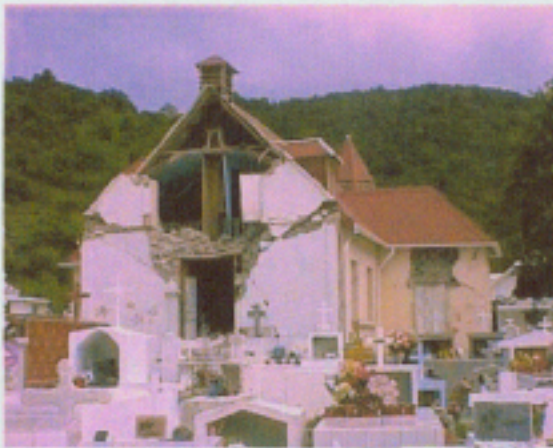
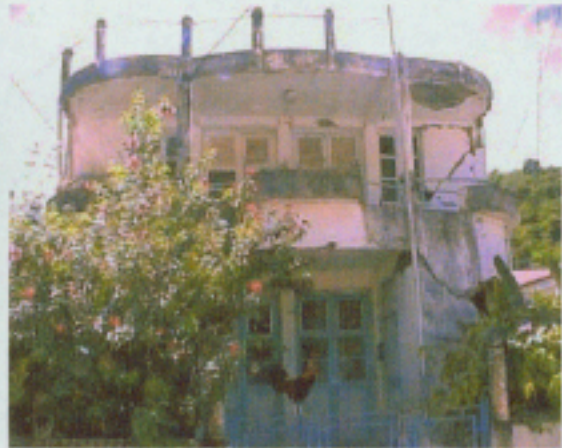
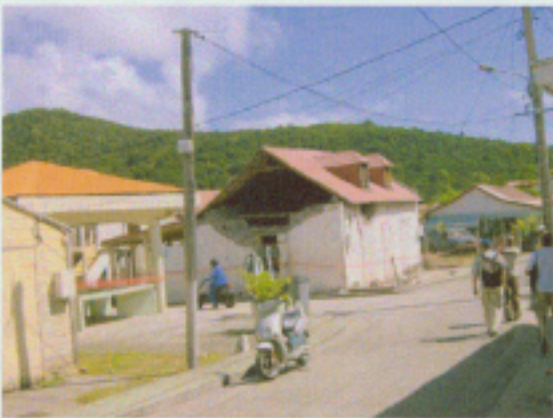
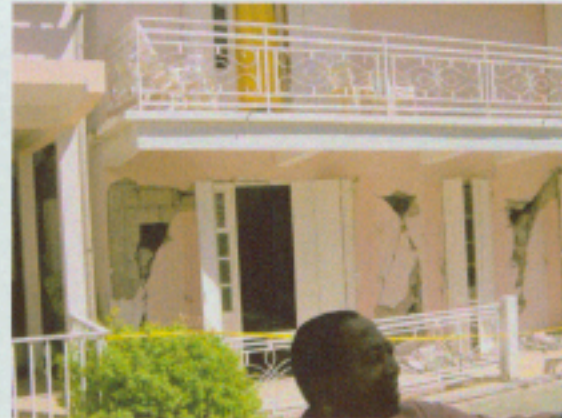
**Figure 3.** Houses damaged by the earthquake at Petites-Anses, Terre-de-Bas Island (Les Saintes, Guadeloupe; Photographs by N. Zahibo and A. Yalçiner).

**Village of Petites Anses.** At least eight houses were destroyed and twenty-five damaged in this village (Figure 3). At the small bay “Anse à Dos” (see Figure 10 for location), a fisherman said that water receded a distance of 2 to 3 m just after the earthquake, and then rose back to normal level.

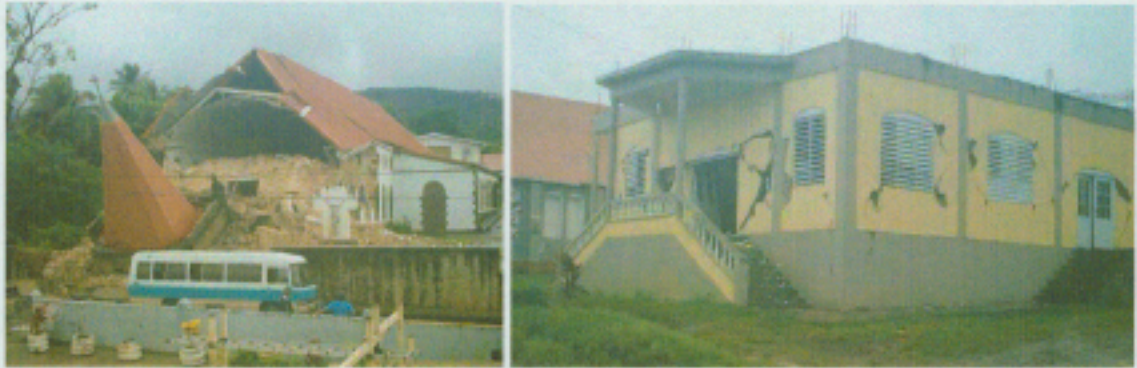
**Figure 4.** Roman Catholic and Methodist Churches at Portsmouth, Dominica damaged during the earthquake (Wayne Abraham, <http://dominicapsn.freeyellow.com/gallery.html>).

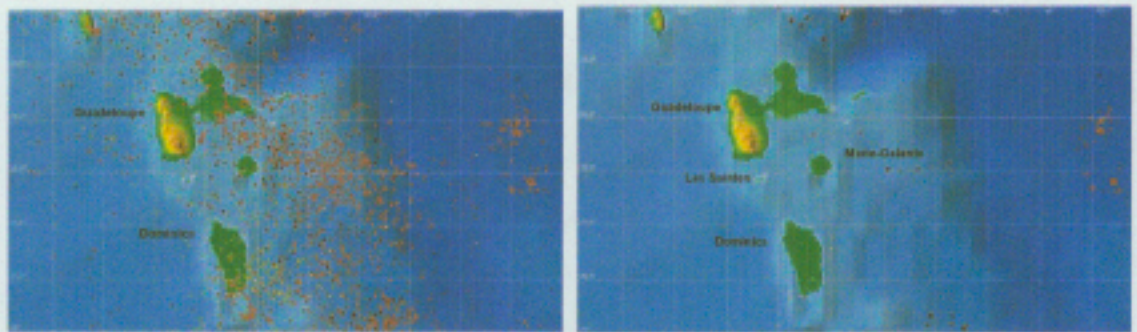
**Figure 5.** Seismicity of Guadeloupe and Dominica (left), and distribution of earthquakes with magnitudes greater than 5.0 (HTDB/ATL, 2002). Note that, before the November 2004 earthquake, the latter were concentrated at the trench.

As documented on Figure 5 (HTDB/ATL, 2002), the seismicity of the area is generally high, but most earthquakes remain weak, with only eight events (listed in Table 1) exceeding a magnitude of 6.

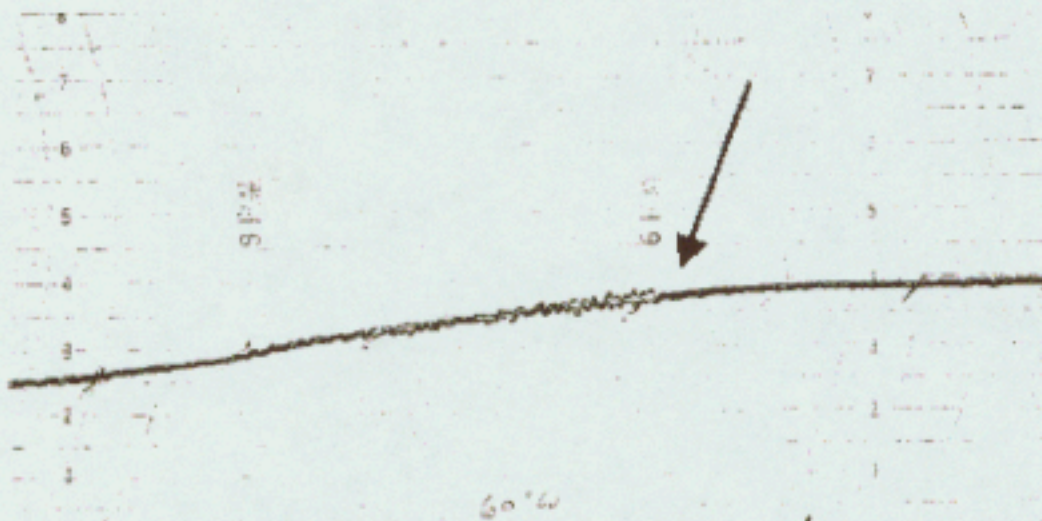
The earthquake of December 25, 1969 ( $m_b = 6.4$ ;  $M_s = 7.5$ ;  $M_0 = 7.8 \times 10^{19}$  Nm; Stein *et al.*, 1982) was felt on Guadeloupe, Dominica, Martinique, St. Vincent, Antigua and Barbados. It was accompanied by a weak tsunami recorded at Barbados, Antigua and Dominica, with a maximum amplitude of 46 cm at Barbados. The single tide-gauge record of this event at Dominica (maximum amplitude 12 cm) is presented in Figure 6.

**Figure 6.** Tsunami of December 25, 1969 recorded at Dominica (Shepherd, 2001).

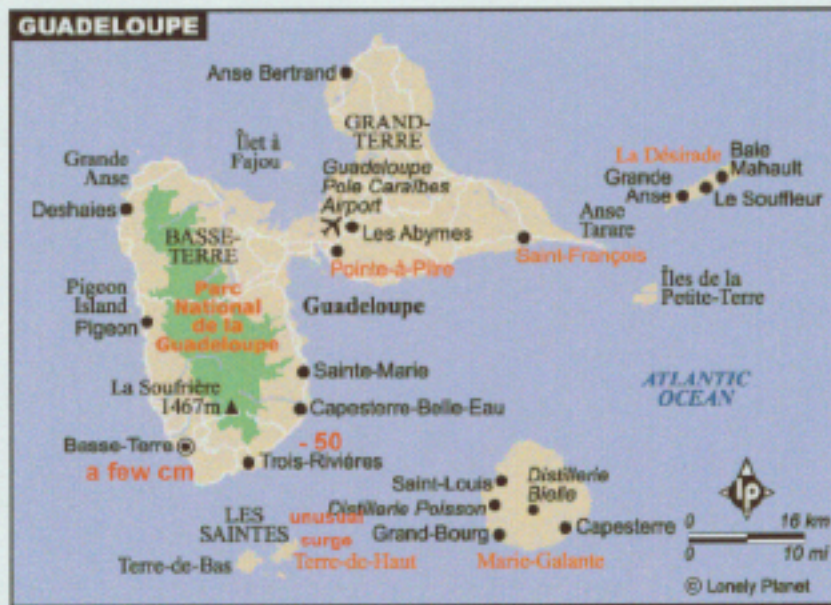
Figure 7. Map of the main island of Guadeloupe.

Basse-Terre (part of the main Island of Guadeloupe) (see Figure 7 for location of all points, and tsunami heights in cm).

**Island of Terre-de-Haut, Les Saintes.** As one witness reported, an “unusual” surge was observed in “Baie du Marigot” (see Figure 7 for location), but there were no reports of earthquake damage from that island.

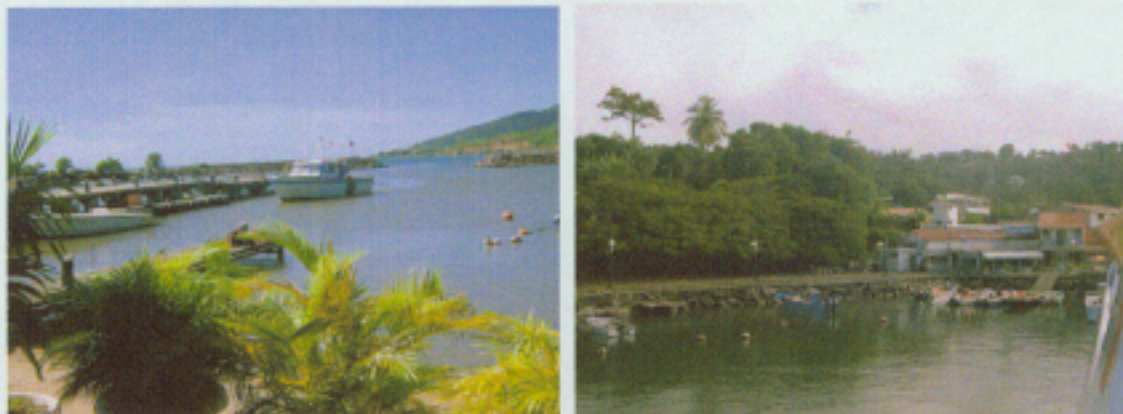
**Village of Trois-Rivières.** One person (a 5-year old girl) was killed, at least two other injured, and several houses destroyed or damaged in this village (Figure 3). In the port ( $15^{\circ}58'084N$ ,  $61^{\circ}38'695W$ ), one fisherman reported that his boat dropped down about 50 cm during the earthquake and then rose back; he was afraid his boat could hit the sea bottom and tip over. A panorama of this port is shown in Figure 8.

Figure 8. Panorama of the port of Trois-Rivières, where the reported tsunami depression was about 50 cm

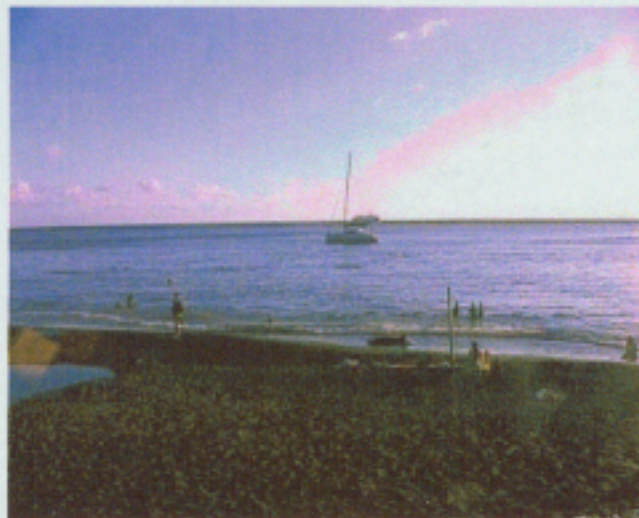
**Marina de Rivière Sens (city of Basse-Terre).** One witness informed us that the water dropped down a few cm and then rose back during the earthquake. A panorama of the beach where the tsunami was recorded is shown in Figure 9.

Figure 9. Panorama of the Marina de Rivière Sens, where the tsunami was reported as a weak depression.

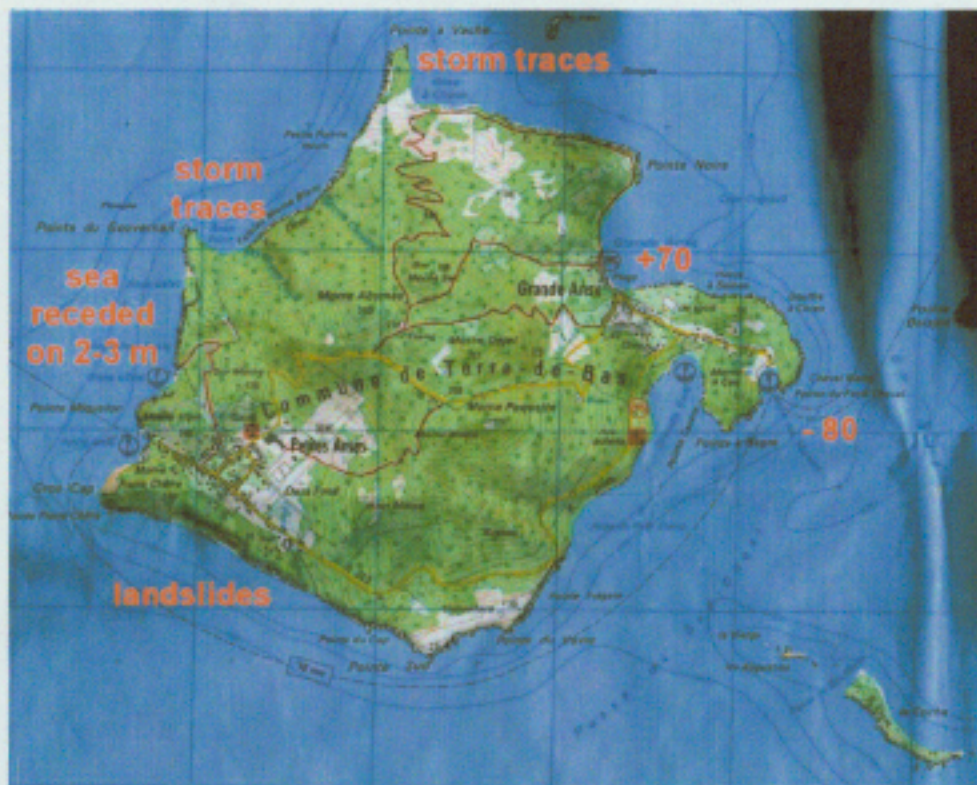
Figure 10. Map of Terre-de-Bas Island.

**Island of Terre-de-Bas, Les Saintes** (see Figure 10 for location of points and wave amplitudes).

**Bay “Anse Pajot”** (see Figure 10 for location). A watermark at a height of about 50 cm was found on February 12, 2005 during the second survey around Terre-de-Bas (Figure 13). Early observation of these traces by local inhabitants suggests their deposition by storm surges, even though no major precipitation occurred since the day of the tsunami.

**Bay “Anse à Chaux”** (see Figure 10 for location). Large watermarks are also visible on the beach in this bay (Figure 14). Here again, storm surges are preferred as their origin. According to reports from fishermen, storm waves approach mainly from the North, and this explains why such watermarks would be found only in those two bays, favorably open to the prevailing winds.

The southwest part of the coast, between capes “**Pointe-Sud**” and “**Gros Cap**” (see Figure 10 for location), facing directly towards the earthquake epicenter, features many fresh rockslides and landslides (Figure 15), identified by local residents as triggered during the earthquake. There, the coast is locally very steep (with cliffs as high as 30 m), and the identification of potential tsunami deposits is thus very difficult. On the South-east coast, from “Grande Baie” to “Pointe Frégate”, the beach is lower (Figure 16), but we could not find definitive tsunami traces.

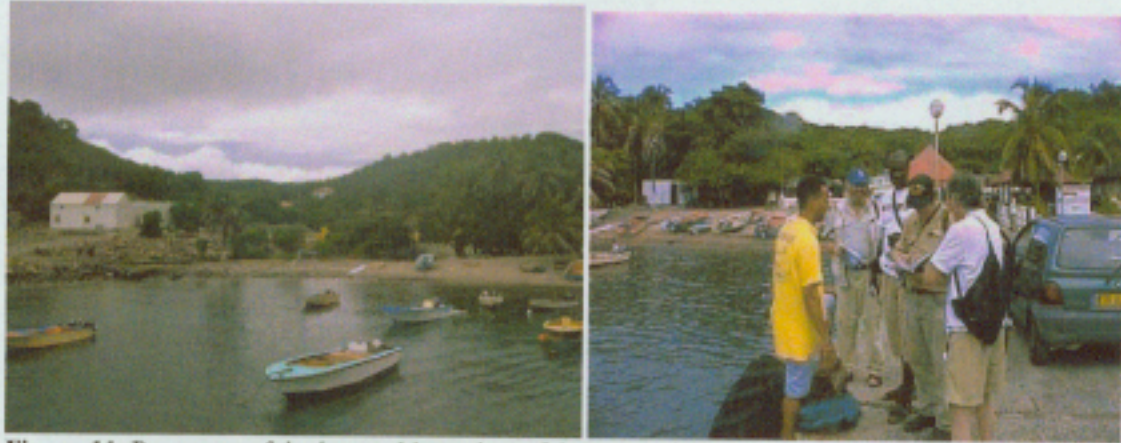
**Village of Grande Anse, Bay "Anse des Muriers"** ( $15^{\circ}51'260N$ ,  $61^{\circ}36'968W$ ). A ship captain reported that 3 minutes after the earthquake, the sea receded 5 m (and dropped 80 cm) and rose back to its still level, over perhaps 1 minute. Photographs of this bay are given in Figure 11.

Figure 11. Panorama of the bay and interview of the tsunami witness in Bay "Anse des Muriers".

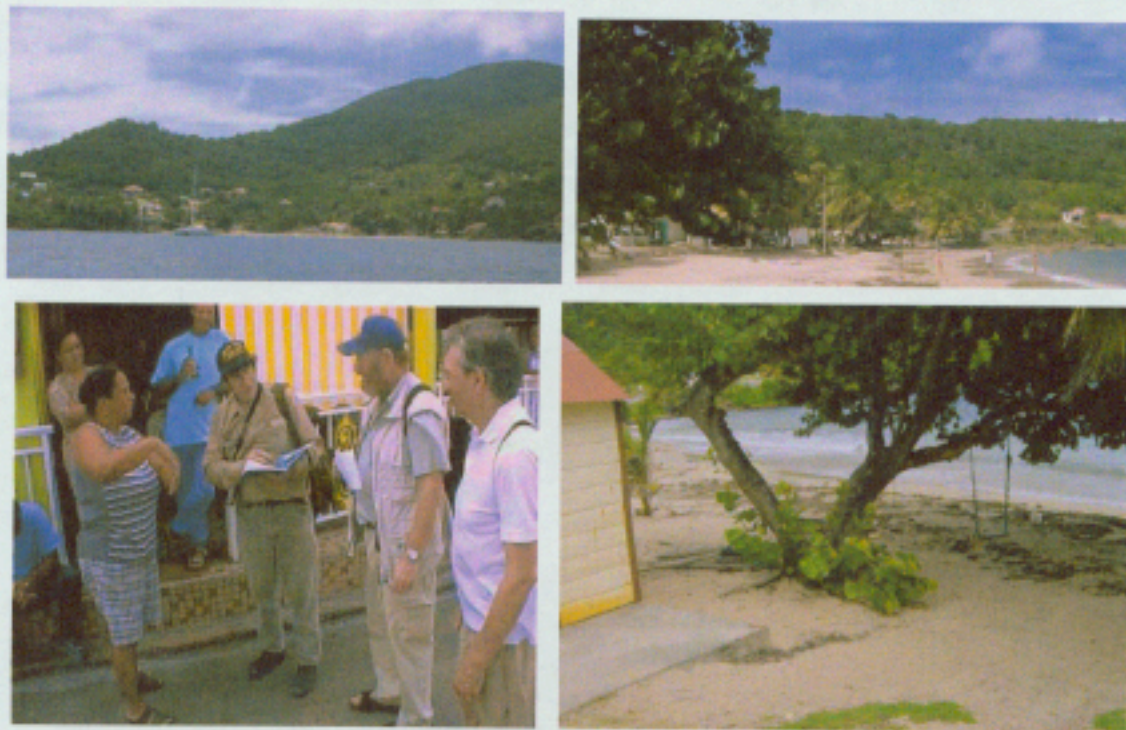
Figure 12. Panorama of the bay "Grande Anse", and interview with restaurant owner (left); the tsunami reached the house on the beach (right).

**Beach of Grande Anse** ( $15^{\circ}51'547N$ ,  $61^{\circ}37'476W$ ). A restaurant owner informed us that the tsunami began as an ebbing phase, and then a positive wave reached a house on the beach; we surveyed this run-up as 70 cm (see Figure 12). According to this witness, the wave shape was

like an undular bore, which could have resulted from significant wave dispersion on this locally very gently sloping beach.

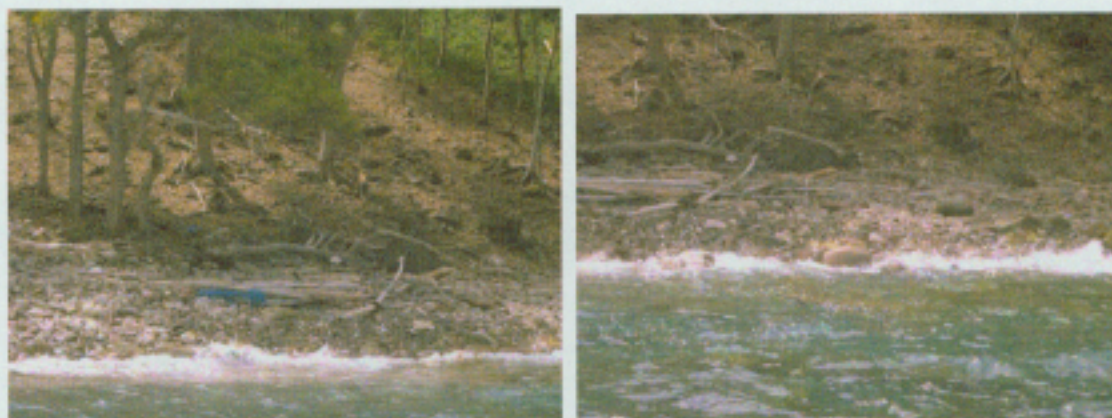
Figure 13. Watermarks in the bay “Anse Pajot”.

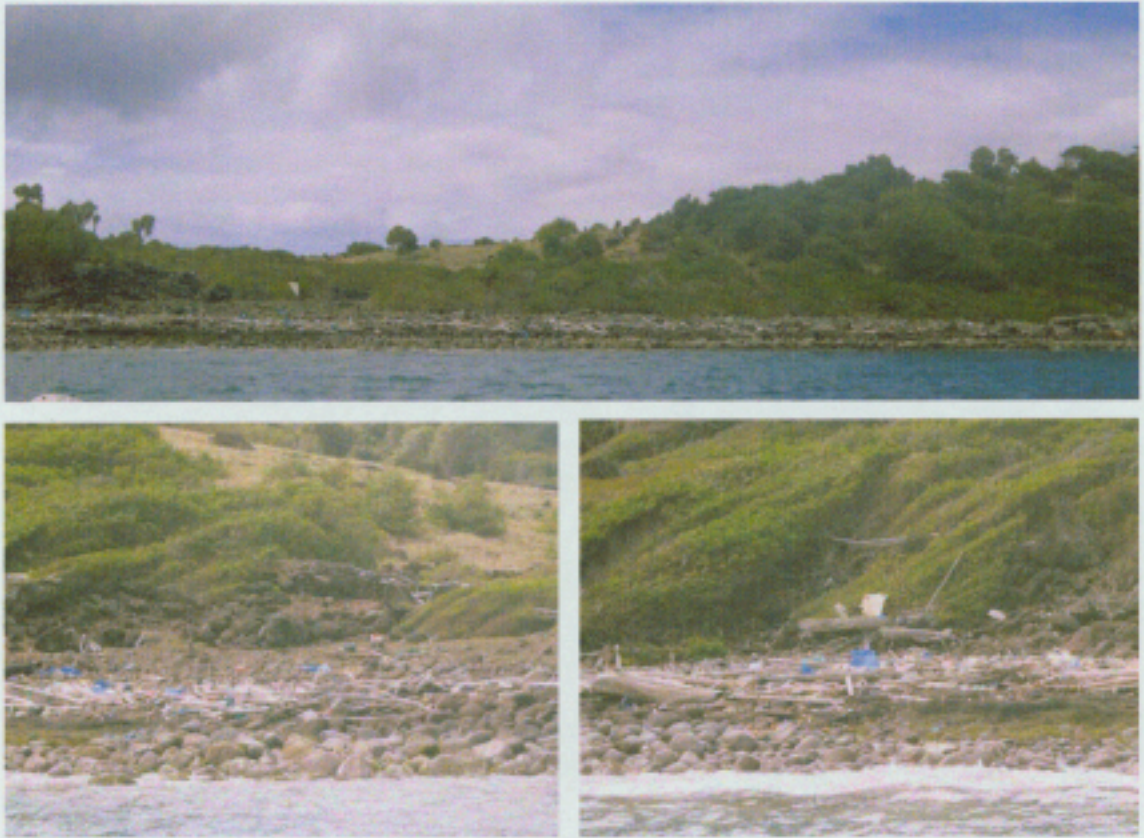
**Figure 14.** Visible traces of the wave runup in the bay “Anse à Chaux”.

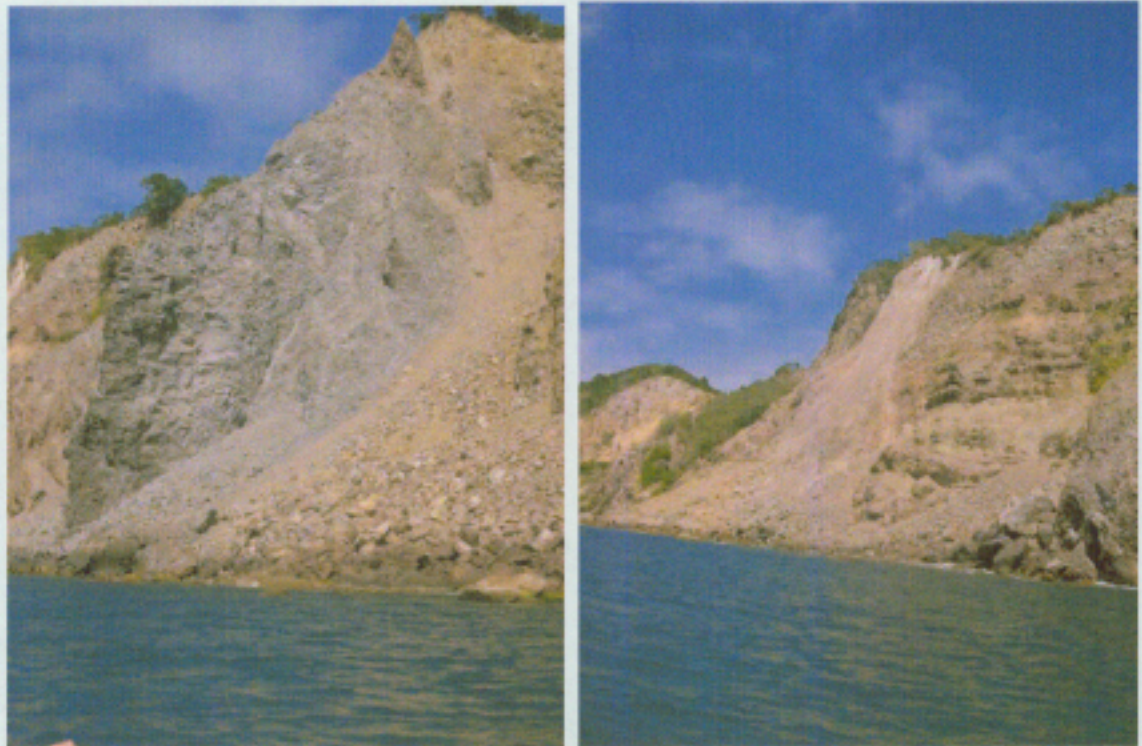
**Figure 15.** Locations of rock- and land-slides on the Southwest coast of Terre-de-Bas.

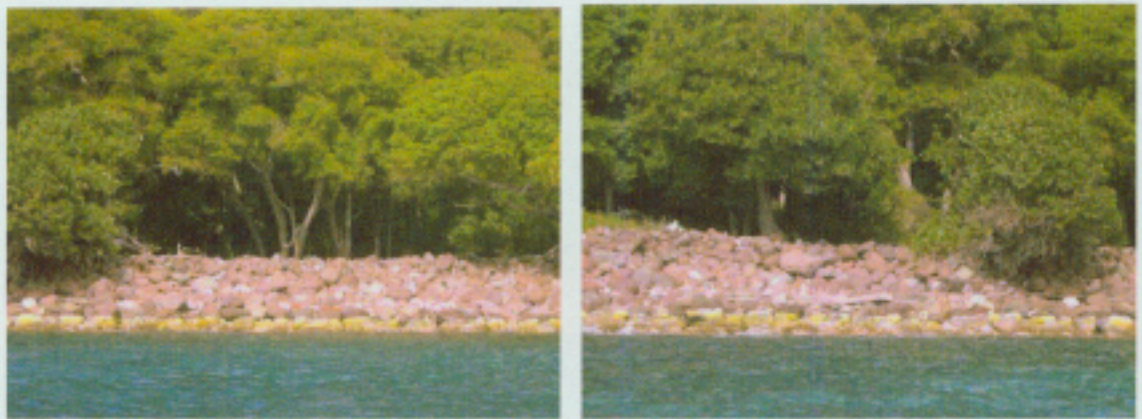
**Figure 16.** Beach on the west part of the bay "Grande Baie", Terre-de-Bas.
